JPT

Deep-Sea Mining Taps Oil and Gas Technology

Addressing the Mounting Challenge of Produced-Water Metering Inaccuracy With Nanotechnology

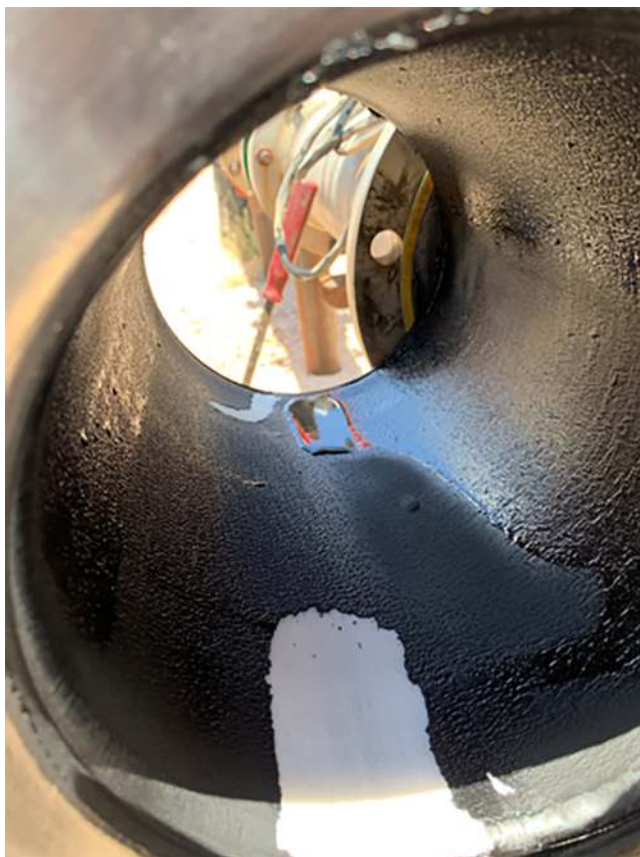
Fig. 1—Electromagnetic flowmeter fouled with paraffin prior to AMI treatment.

Paraffin buildup affects the accuracy and reliability of electromagnetic flowmeters as it nucleates on the electrodes and the liner of the meter. Over time, the paraffin deposition will increase around the electrodes, essentially insulating the electrodes from the fluid. At this point the conductivity of the fluid is artificially reduced, and the flowmeter will under read.

If the paraffin coating on the electrodes becomes thick enough, a flowmeter will be completely insulated from the produced water, which the meter interprets as zero flow. As the paraffin coating on the liner increases, the

cross-sectional area of the meter is reduced, creating a higher fluid velocity which results in the meter overreading the flowrate ($Q = Av$ where A is the cross-sectional area of flow and v is its average velocity).

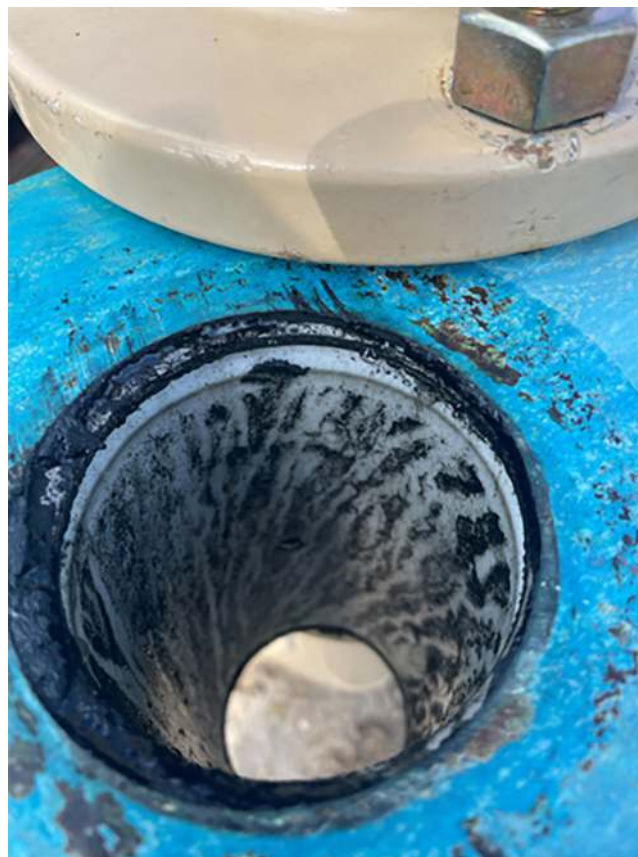
Fig. 2—Electromagnetic flowmeter 180 days post AMI treatment.

Initially, the meters were physically inspected for fouling at 180 days and the electrodes were found to be free from paraffin deposition. The meters have not been pulled for maintenance due to fouling since, as the flow rates reported by the magnetic flowmeter have remained consistent with the operator's daily volumes of produced water.

The AMI service consists of cleaning, preparing, and treating the surface of the magnetic flowmeter with omniphobic surface modification chemistries that repel both water and hydrocarbons. Aculon's omniphobic chemistry is used to treat the ceramic or metallic electrodes and covalently bonds to the surface with a 2-5-nanometer-thick optically clear treatment.
